INSPECTION REPORT

For the Property at:
123 Main ST
FRISCO, TX 75034

Prepared for: John Doe Inspection
Date: Friday, May 1, 2020 Prepared
by: Patrick Evers

PROPERTY INSPECTION REPORT

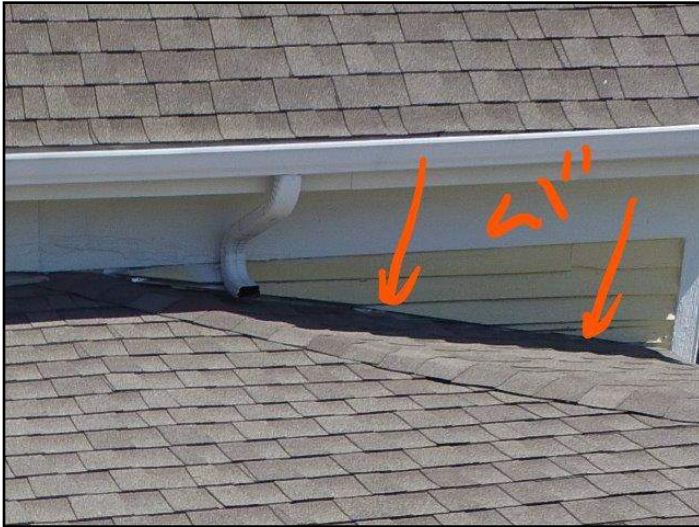
5. Roof Siding/Trim min 1" from Shingles. This...

1. Condition: • Roof Siding/Trim min 1" from Shingles. This should prevent wood rot and moisture wicking into home. Seeing damaged corner from water wicking.

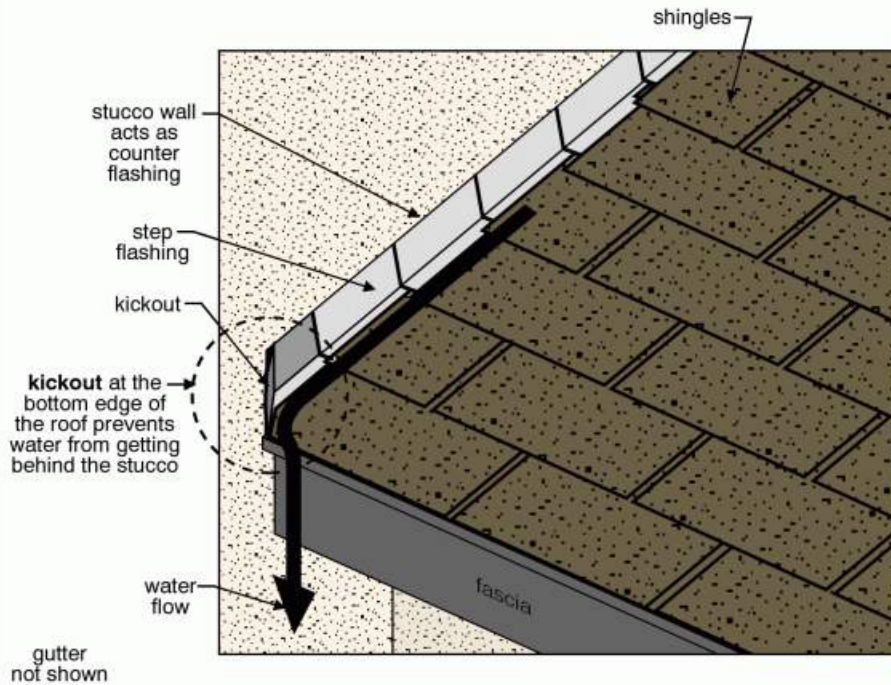
Kick-out flashing

2. Condition: • Kickout flashing - missing

Missing kickouts allow rain water to bypass gutter causing damage to the fascia and soffits. Additionally the water damages the brick and mortar

Implication(s): Chance of water damage to contents, finishes and/or structure

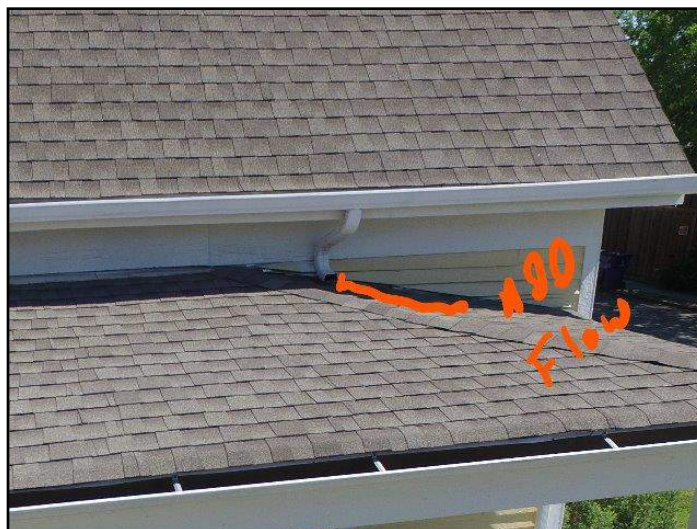
11. Discharge onto roofs

3. Condition: • Discharge onto roofs

Implication(s): Chance of water damage to contents, finishes and/or structure

Redirect water from siding.

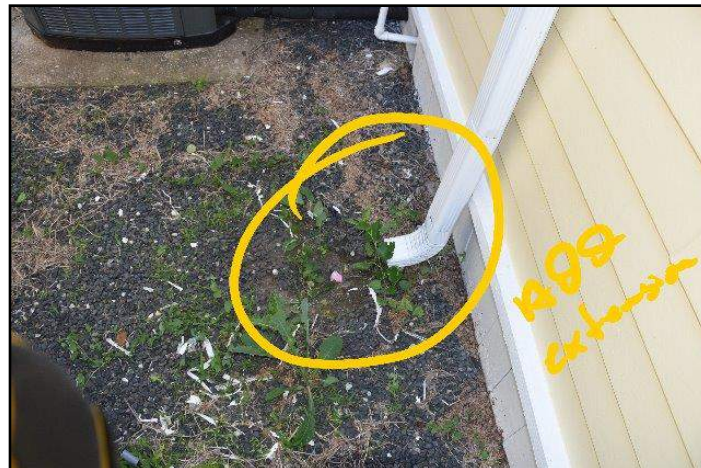
12. Discharge too close to building

4. Condition: • Discharge too close to building

Down spouts need to have 2' extension to prevent under cutting foundation. Additionally redirect water flow away from the house. Need to stop erosion

Implication(s): Chance of water damage to contents, finishes and/or structure

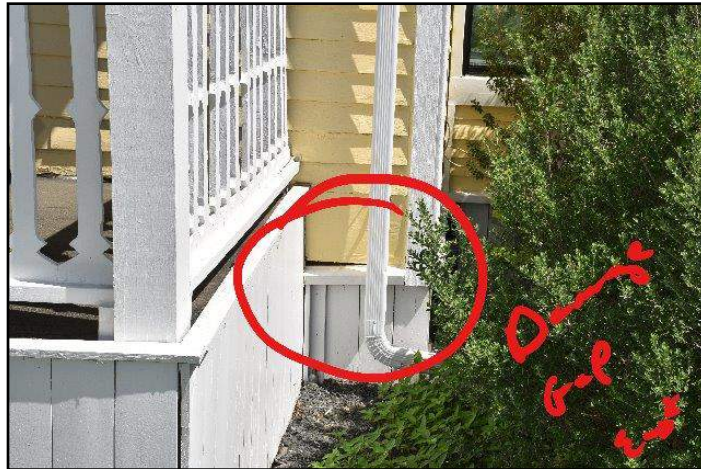
13. Damaged Trim

5. Condition: • Damaged Trim

Repair

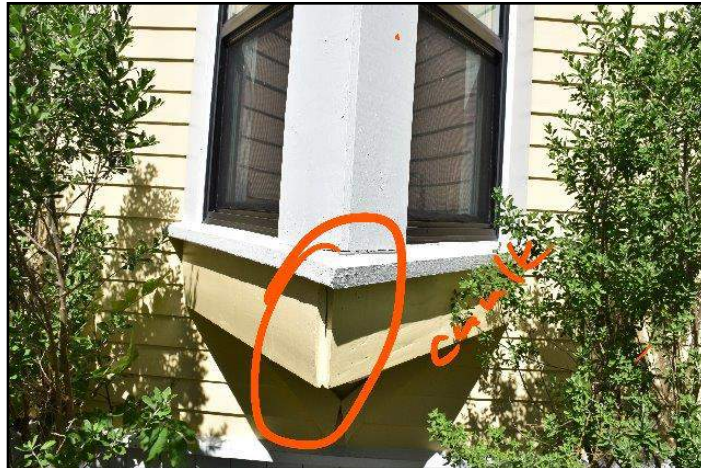
14. Damaged Trim

6. Condition: • Damaged Trim

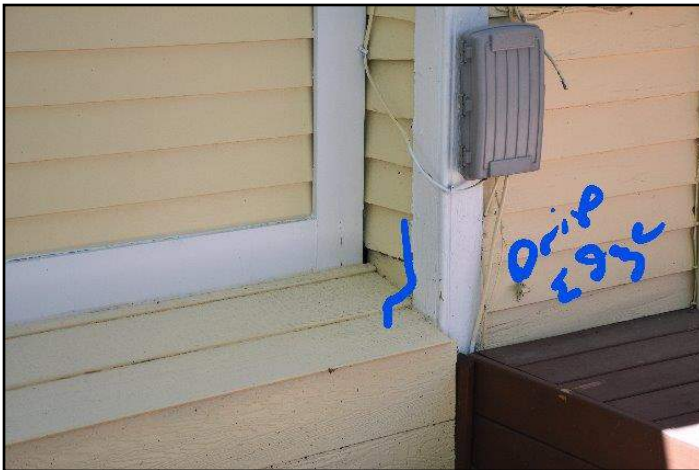
15.

7. Condition: • Missing drip edge

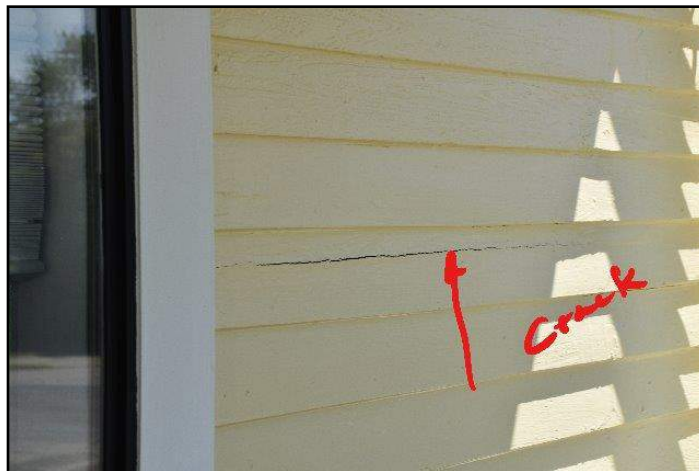
18. Cracked, split or broken

8. Condition: • Cracked, split or broken

Implication(s): Chance of water damage to contents, finishes and/or structure

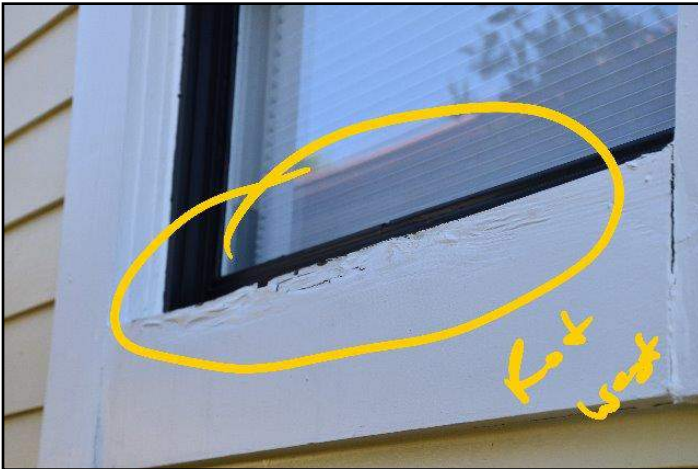
22. Rot

10. Condition: • Rot

Westside lower window trim rot replace.

Implication(s): Chance of water damage to contents, finishes and/or structure | Material deterioration

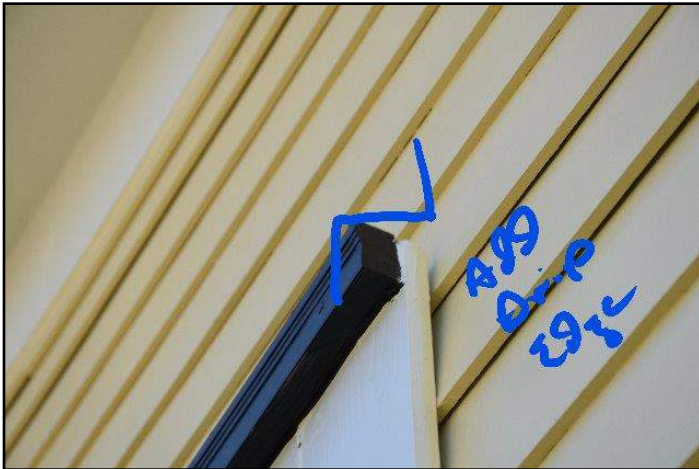
24. Missing

11. Condition: • Missing

Flashing above window trim, issuing water entry point can cause wood rot

Implication(s): Chance of water damage to contents, finishes and/or structure

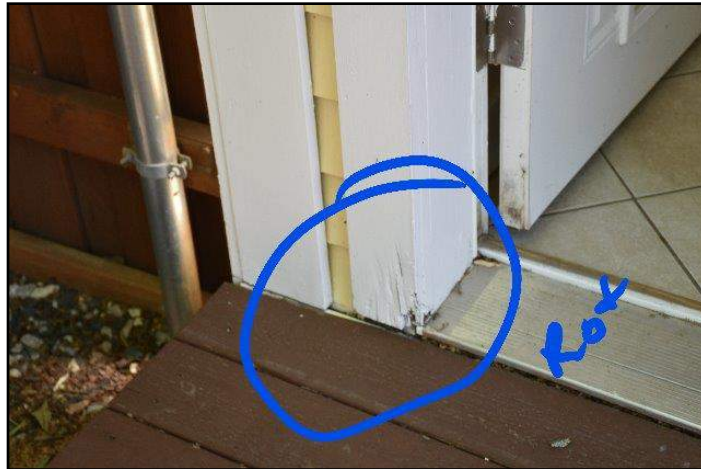
27. Rot

12. Condition: • Rot

Implication(s): Chance of damage to finishes and structure

Repair laundry door trim

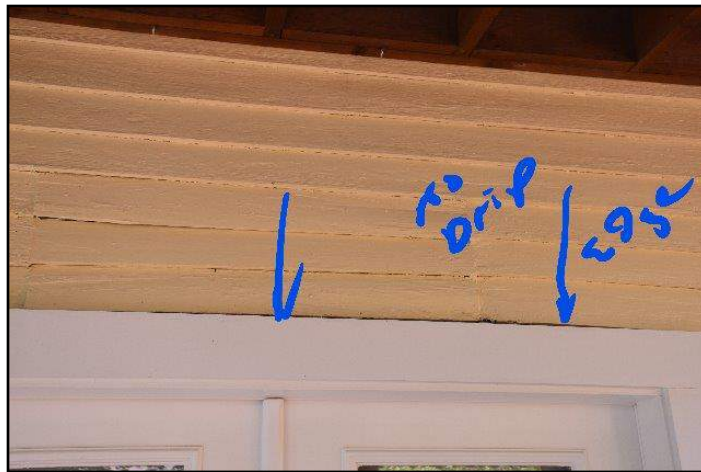
28. Missing

13. Condition: • Missing

Implication(s): Chance of damage to finishes and structure

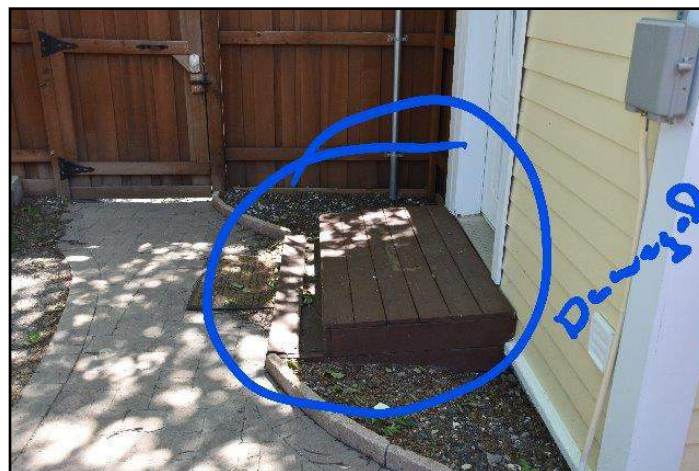
29. Steps springy, loose or sagging

14. Condition: • Steps springy, loose or sagging

Implication(s): Trip or fall hazard

Replace laundry patio damaged replace.

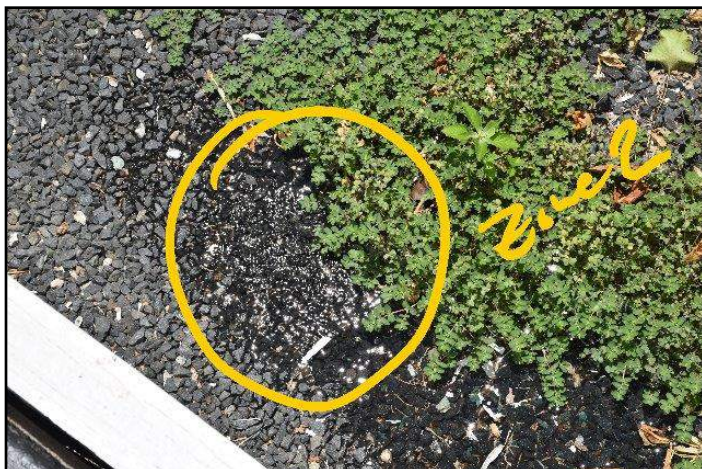
30. Damaged

15. Condition: • Damaged

Zones 2,3, 4 and 5 damaged heads or piping

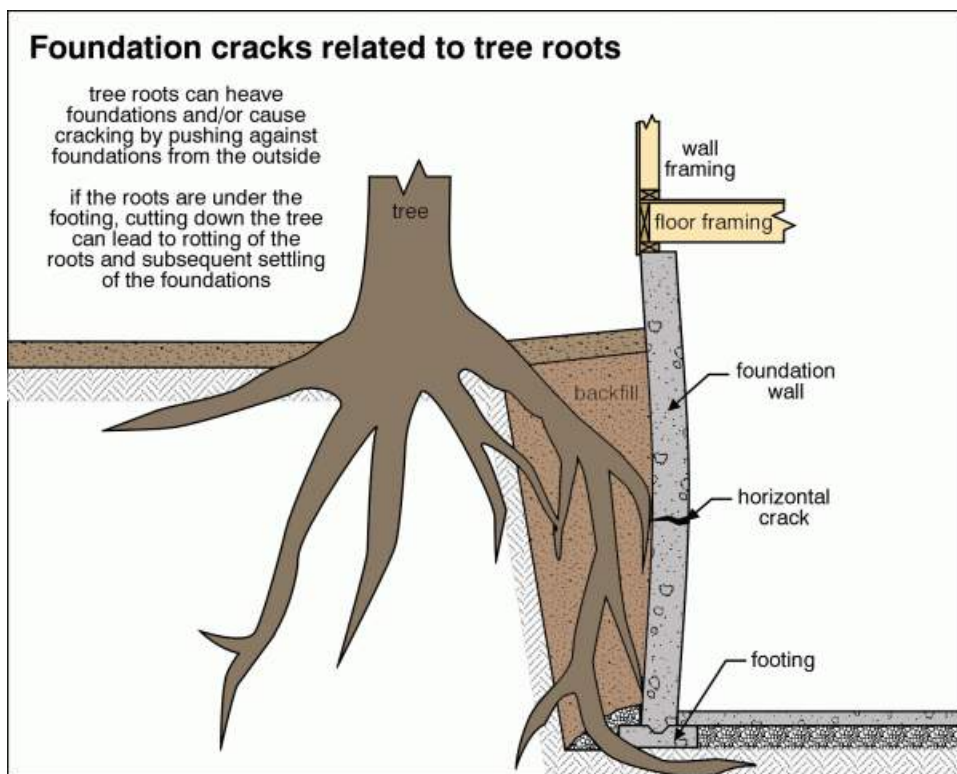
43. Large trees close to building

16. Condition: • Large trees close to building

Implication(s): Weakened structure | Chance of structural movement

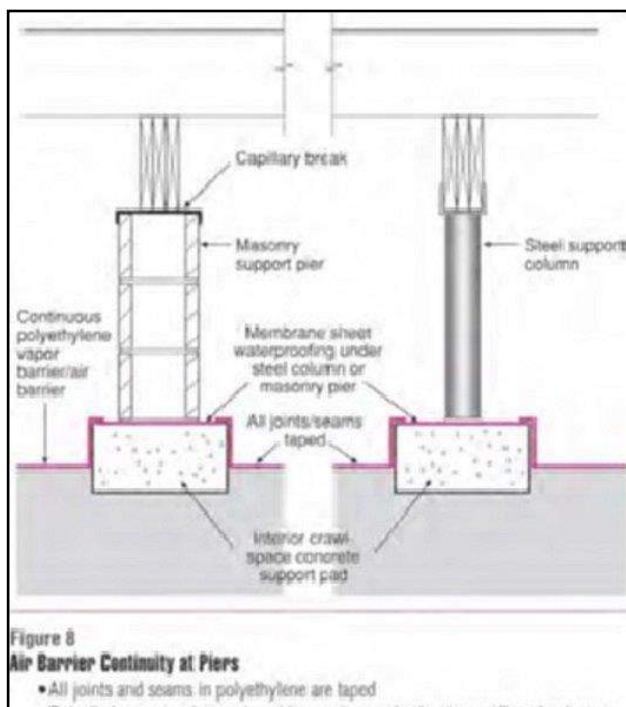
44. No Termite cap

17. Condition: • No Termite cap

Missing termite caps need to add caps to prevent wood damage

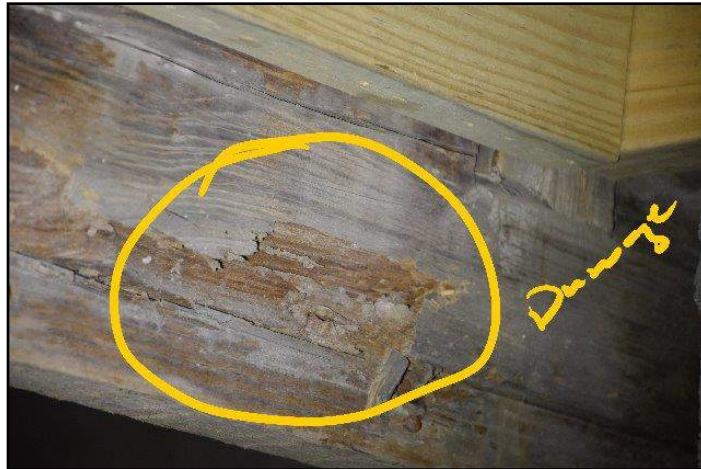
45. Insect damage

18. Condition: • Insect damage

Implication(s): Material deterioration

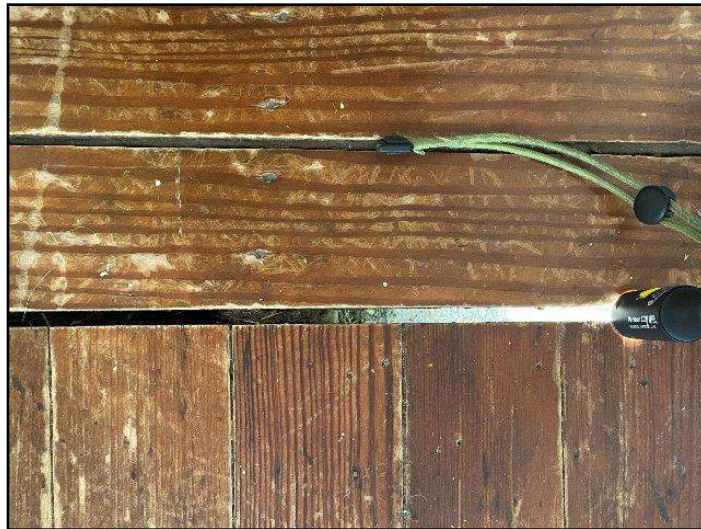
46.

19. Condition: • No floor sheathing under old hardwood flooring.

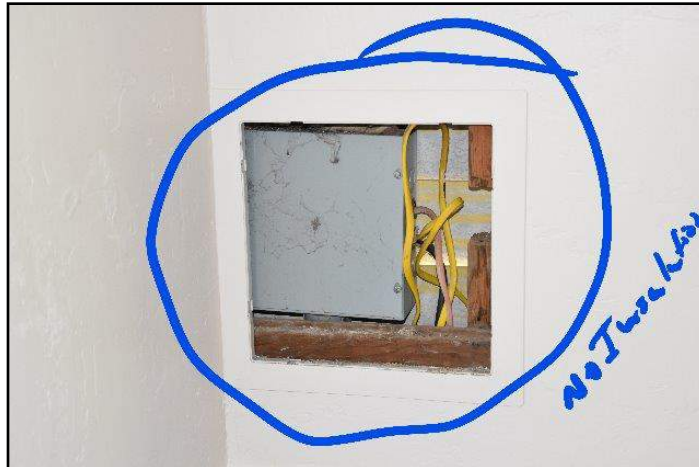
53. Concealed boxes

21. **Condition:** • Concealed boxes

Implication(s): Electric shock | Fire hazard

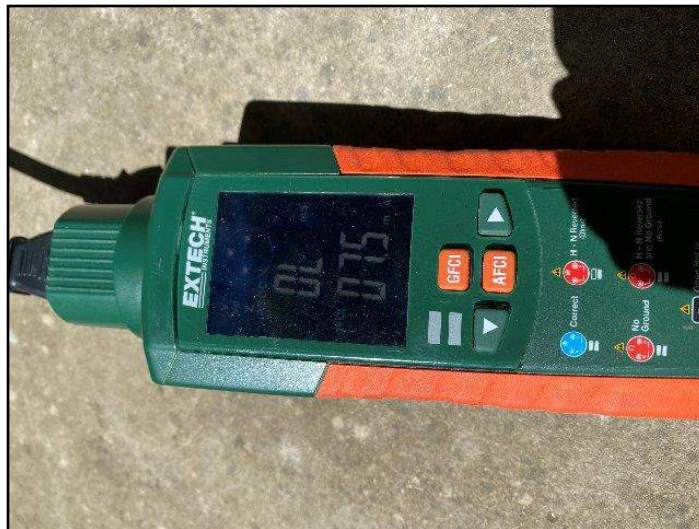
54. GFCI are required in Bathrooms, Garage,...

22. Condition: • GFCI are required in Bathrooms, Garage, Outdoor and Kitchens to prevent electrical shock
Patio grill plug required to have GFCI

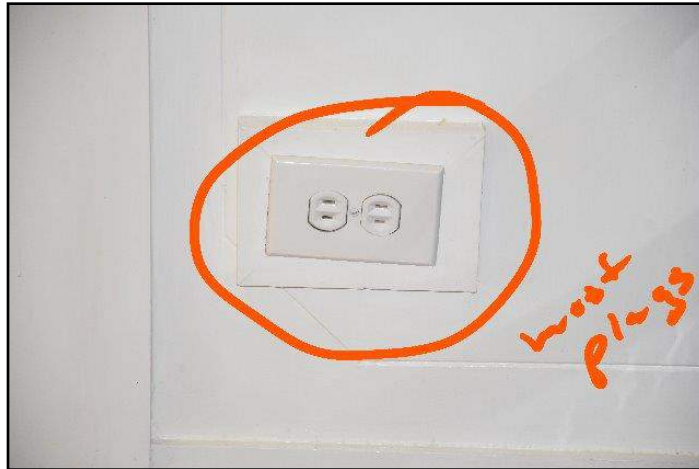
55. 2 prone plugs installed

23. Condition: • 2 prone plugs installed
plugs not grounded will not work with modern equipment. Should be noted ground wires installed in new electrical panel.

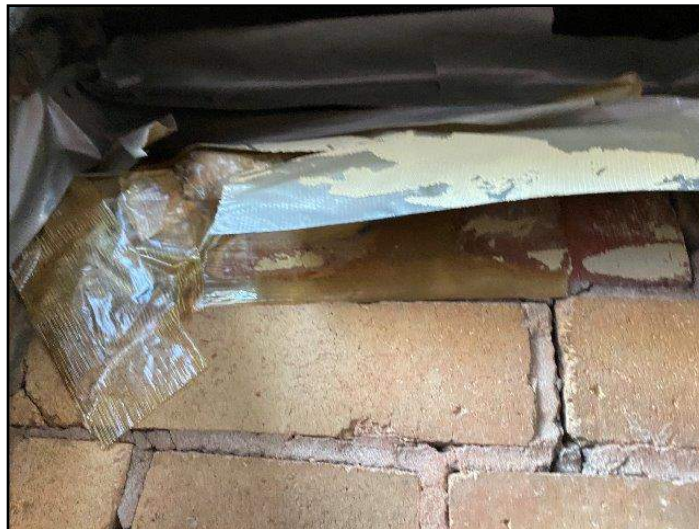
56. *Not functional*

25. Condition: • Not functional

Implication(s): System inoperative

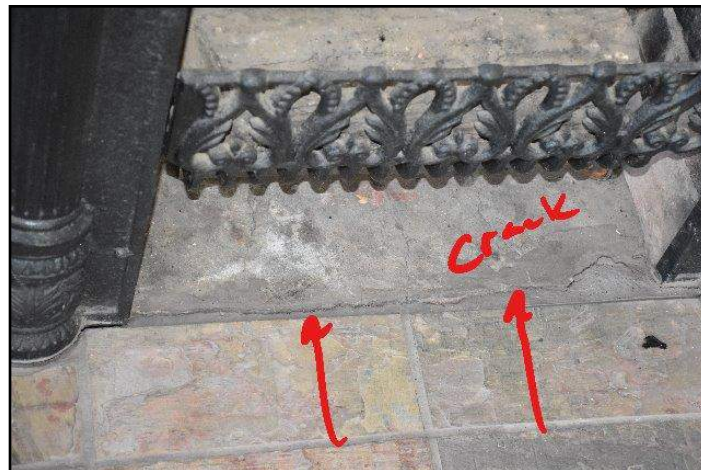
57. Gaps or cracks

26. Condition: • Gaps or cracks

Implication(s): Fire hazard

Repair

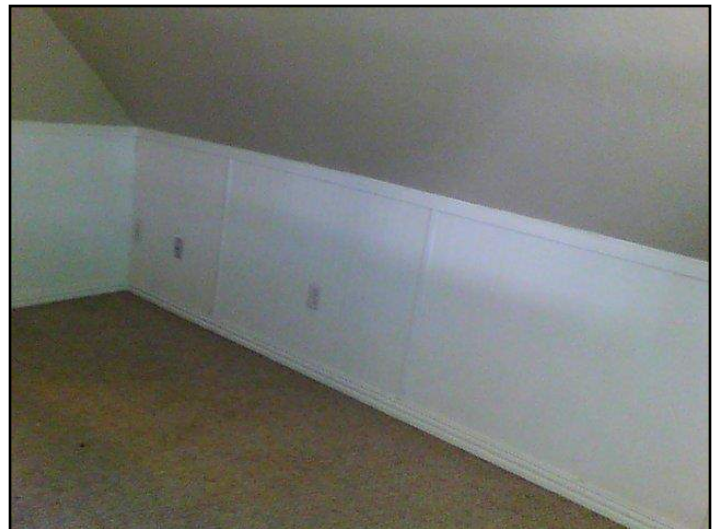
70. Sagging or voids

28. Condition: • Sagging or voids

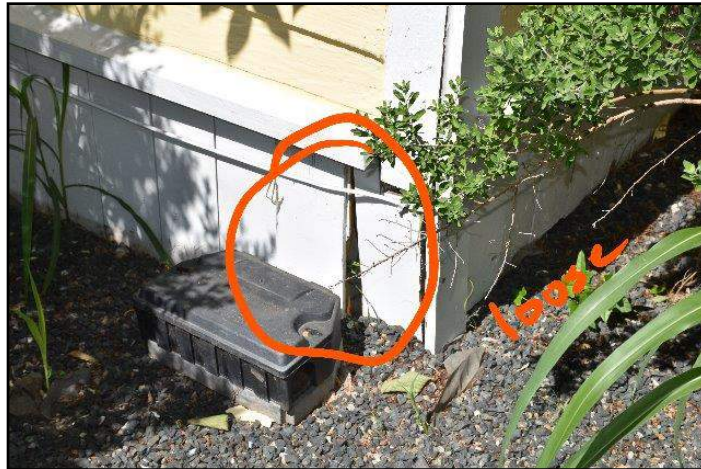
71.

32. Condition: • crawl space siding needs to be repaired.

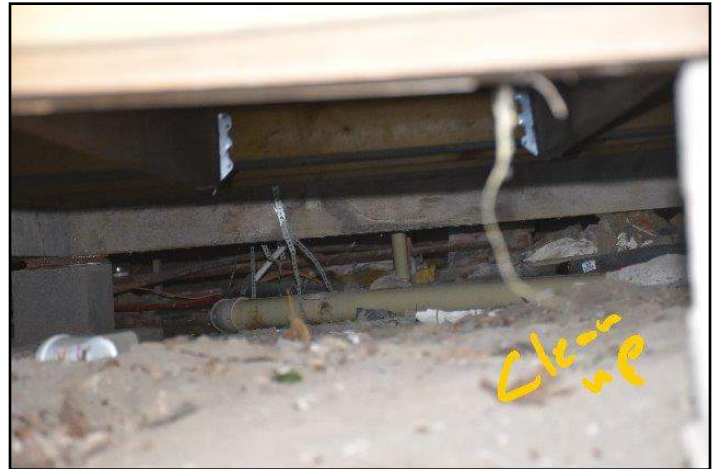
79. Wood and debris on flooring this could...

37. Condition: • Wood and debris on flooring this could attract termite and insects. Remove all wood from flooring.

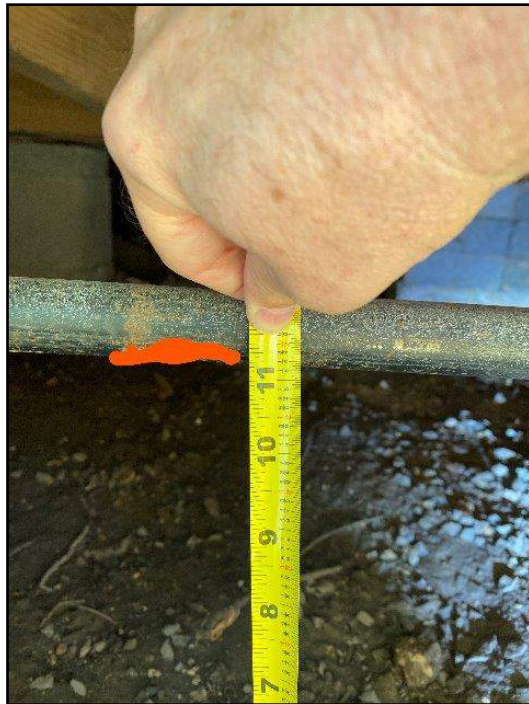
80. Too small

34. Condition: • Access into Crawl Space should be >18" X 24"

39. **Condition:** • Too small

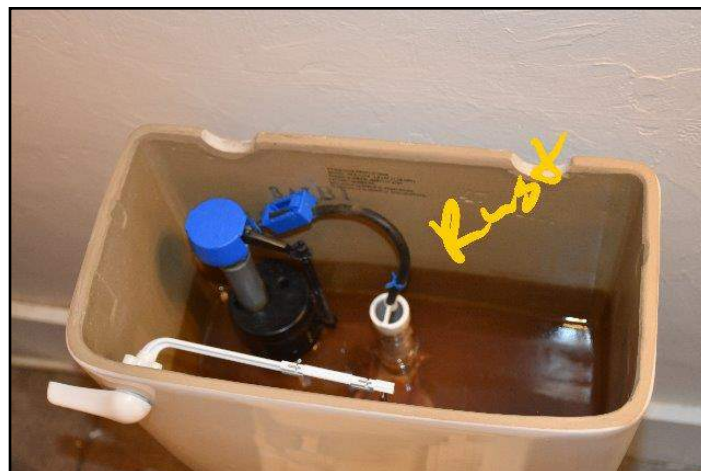
41. Condition: • Rust

Implication(s): Chance of water damage to contents, finishes and/or structure | Leakage | Reduced system life expectancy | Equipment failure

rusting of galvanized pipe can greatly reduce water pressure and will eventually cause leaks as rust creates holes in the pipe walls

problems are likely to occur soonest on pipes carrying hot water, horizontal pipes and at threaded (thinner) sections

2. Install drip edges above windows, doors and wall trim to prevent water intrusion.
3. Replace galvanized water piping with PEX or PVC. Will help prevent rusty water.

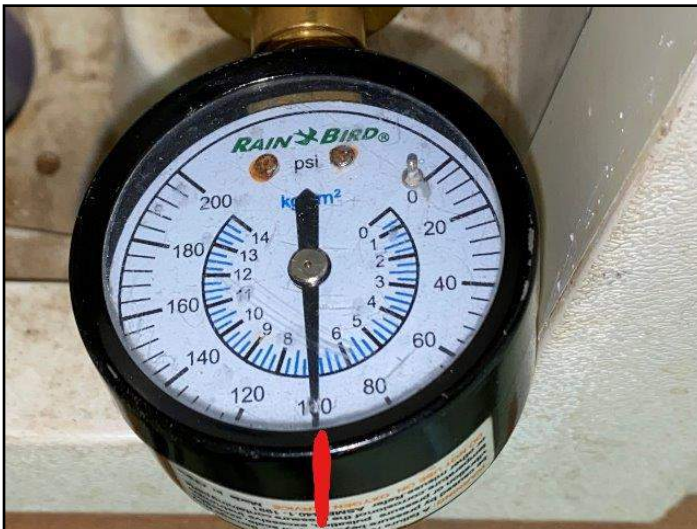
86. Recommended due to high supply water...

42. Condition: • Recommended due to high supply water pressure

Implication(s): Chance of water damage to contents, finishes and/or structure | Damage to equipment

Pressure regulator required

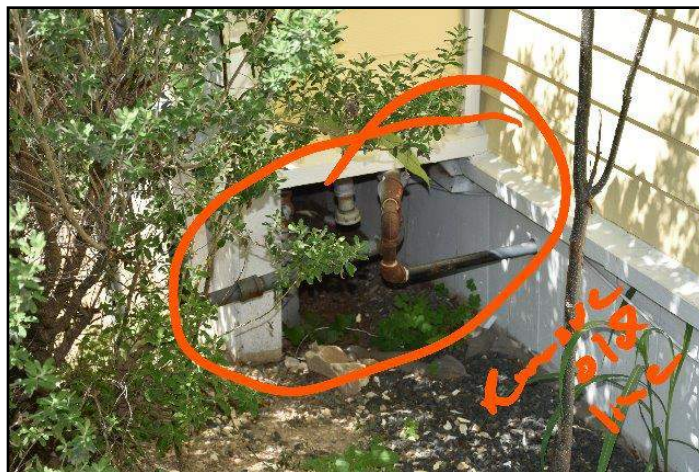
88.

43. Condition: • Remove abandon gas lines

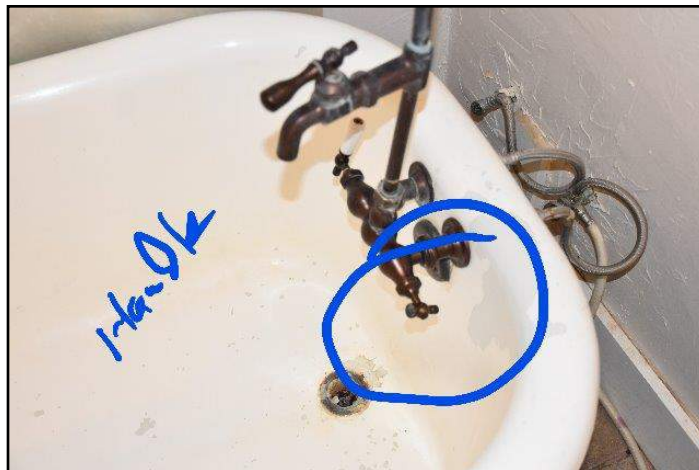
90. Missing Handle

45. Condition: • Missing Handle

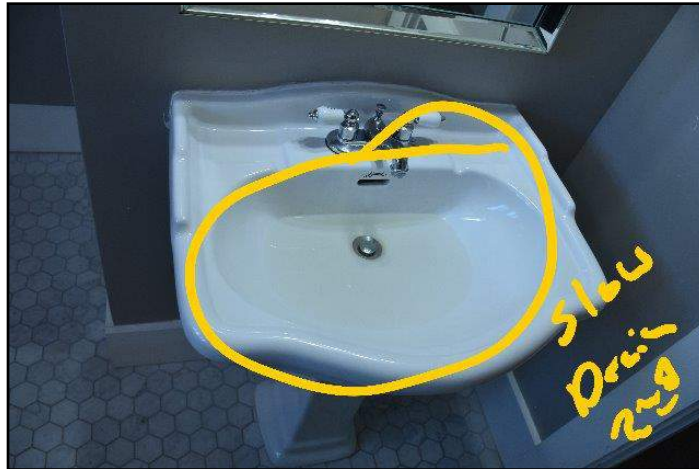
91. Slow drains

46. Condition: • Slow drains

Implication(s): Chance of water damage to contents, finishes and/or structure

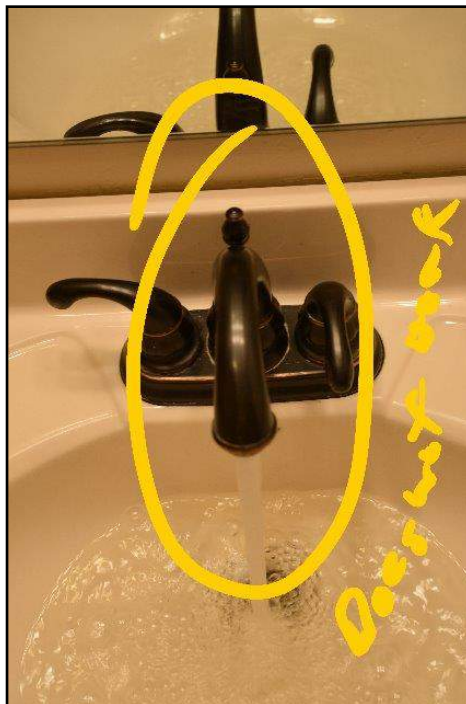
92. Drain stop ineffective

47. Condition: • Drain stop ineffective

Implication(s): Nuisance | Reduced operability

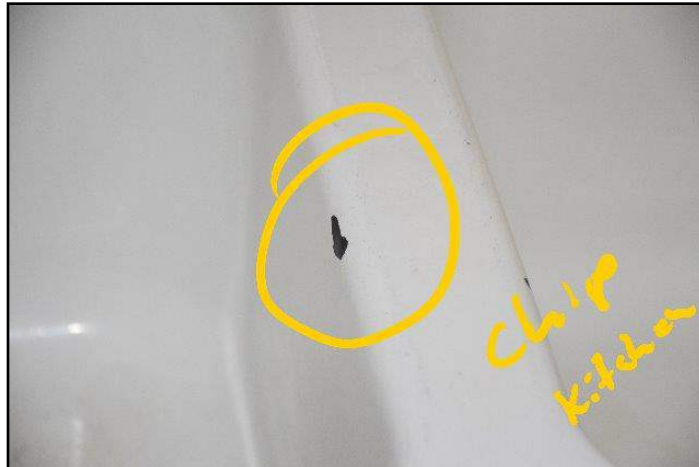
93. Chipped Sink

48. Condition: • Chipped Sink

Location: Kitchen

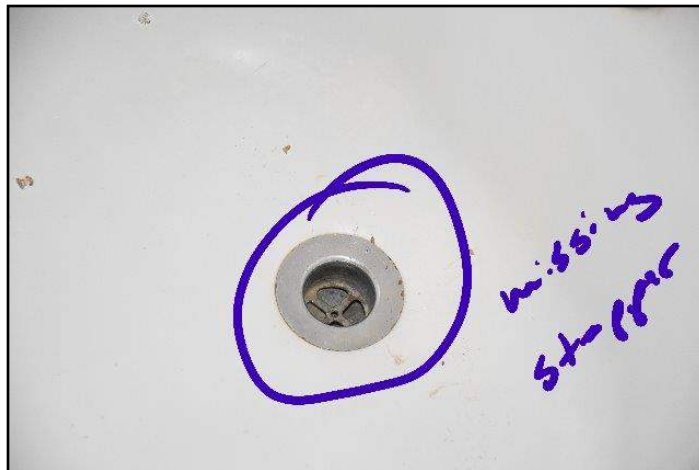
94. Drain stop missing

49. Condition: • Drain stop missing

Implication(s): Reduced operability

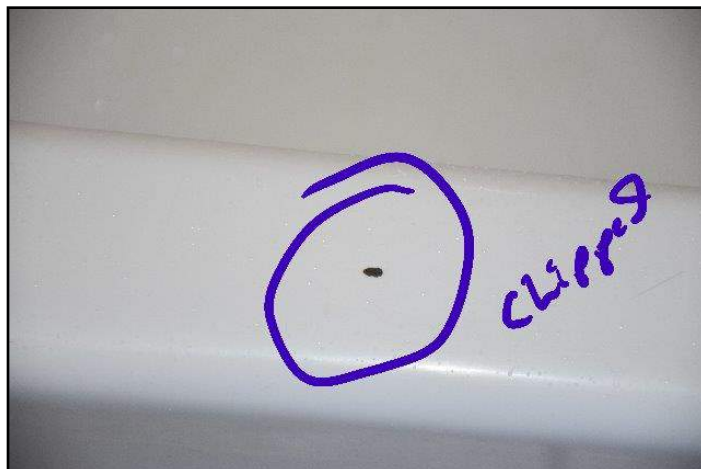
95. Cast Iron Tub Chipped

50. Condition: • Cast Iron Tub Chipped

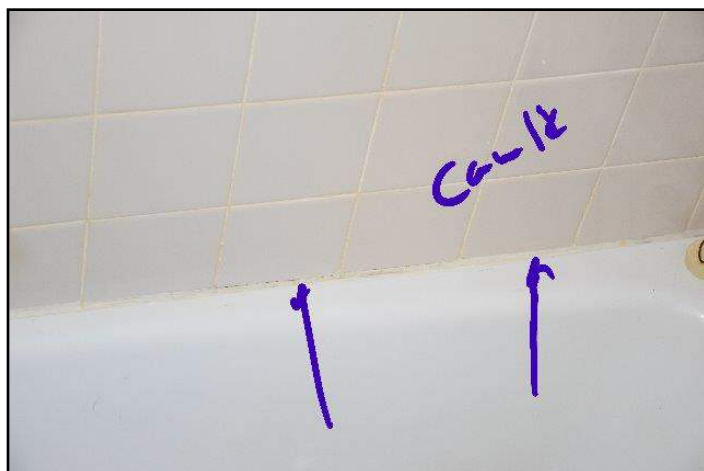
96. Caulk Tub and Tile interface water entry...

51. Condition: • Caulk Tub and Tile interface water entry point can loosen tiles.

Location: Hallway Bathroom

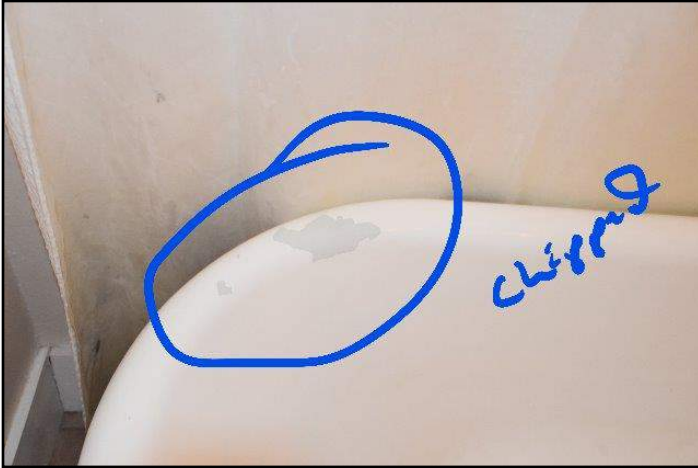
100.

52. Condition: • Tub resurfacing/paint chipping needs to be repaired.

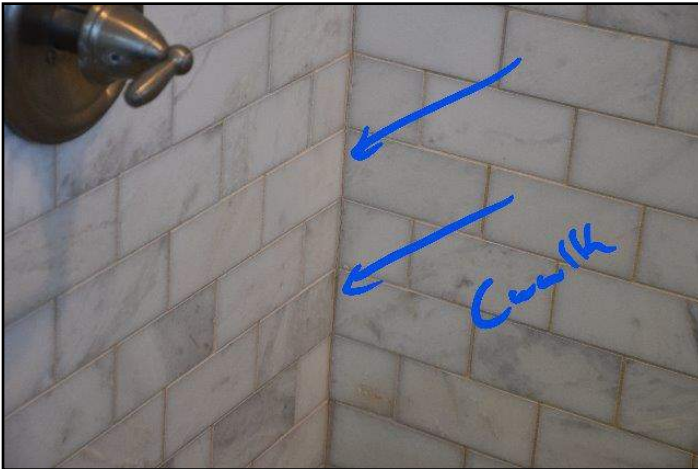
103. Caulking loose, missing or deteriorated

Implication(s): Chance of water damage to contents, finishes and/or structure

Location: Second Floor Hallway Bathroom

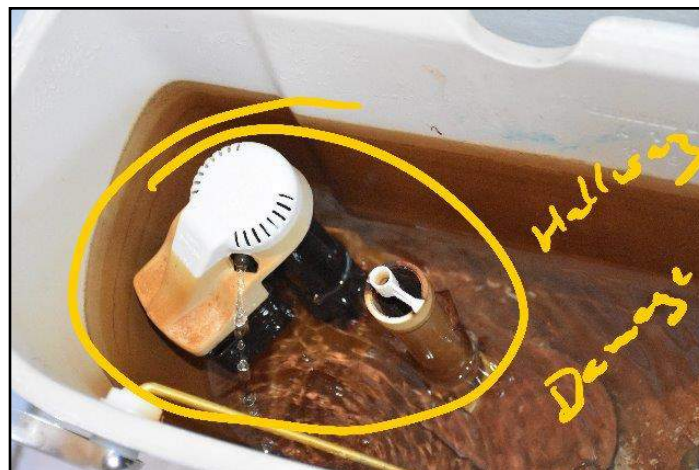
106. Flush mechanism inoperative

54. Condition: • Flush mechanism inoperative

Implication(s): Equipment failure | Sewage entering the building

Location: Hallway Bathroom

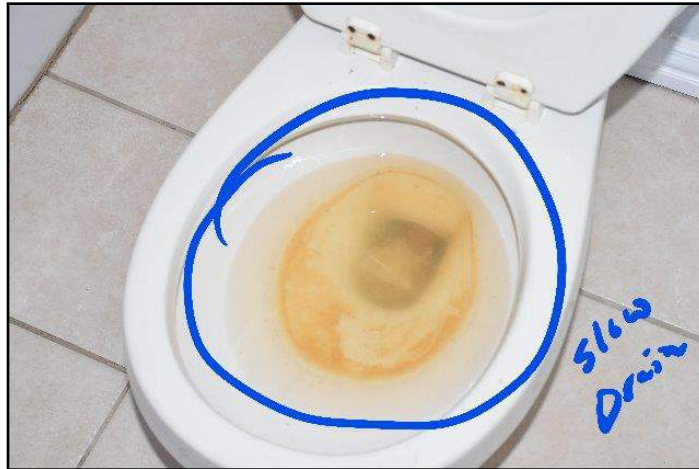
107. *Obstructed or weak flush*

55. Condition: • Obstructed or weak flush

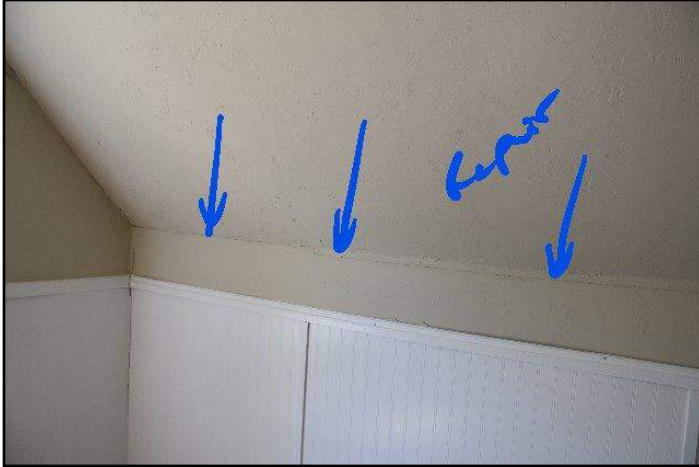
111. Minor Settlement Cracks

57. Condition: • Minor Settlement Cracks

Repair cracks in 2nd floor SE room.

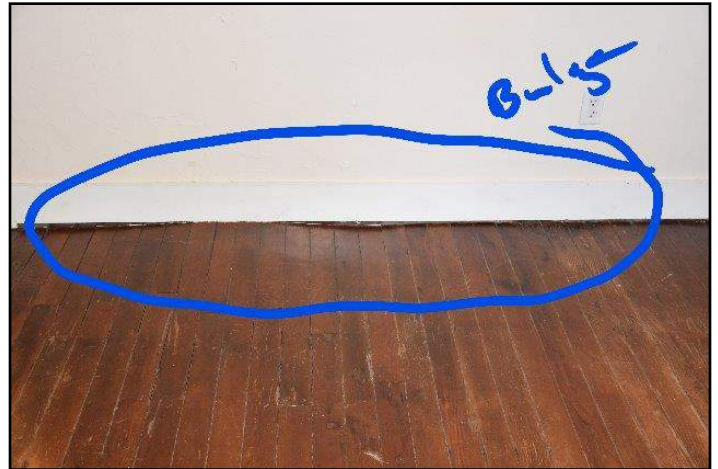
115. Buckled

Wood/laminate floors: **Buckled** Notes: **Repair flooring in master bedroom**

4. Water pressure high install pressure regulator.
5. Replace laundry patio damaged replace.
6. Repair buckling floor in master bedroom
7. Major insulation void and missing insulation in ceiling and walls upstairs and in master bedroom. Recommend using foam for filling in gaps and voids.

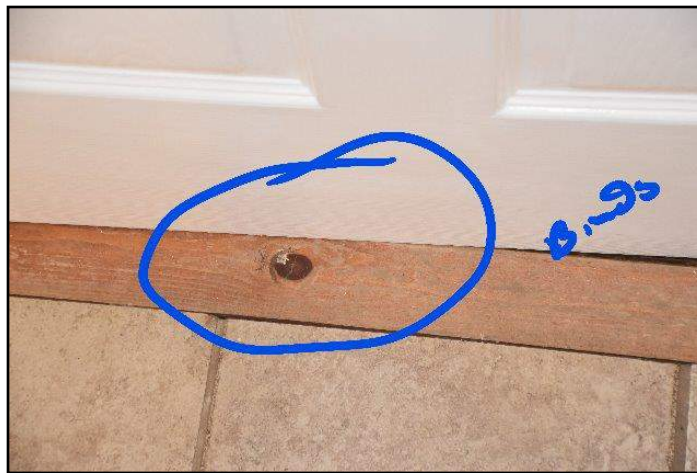
116.

60. Condition: • Door drags at bottom will not shut.

Location: First Floor Master Bathroom

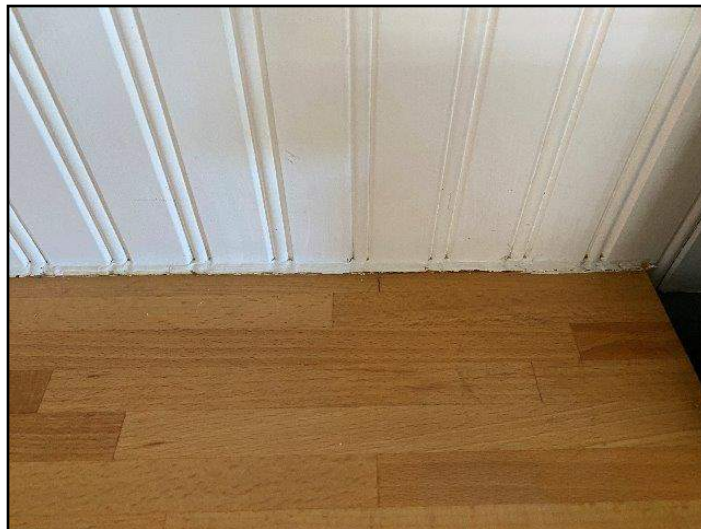
118. Re Caulk Water Entry Point.

62. Condition: • Re Caulk Water Entry Point.

Location: Kitchen

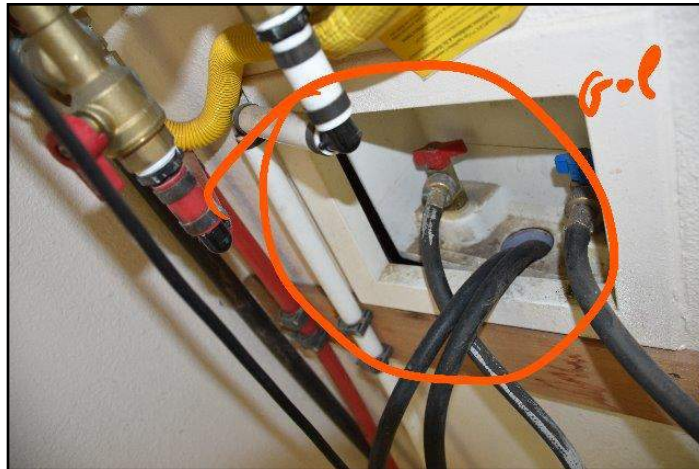
120.

64. Condition: • water enclosure loose
