INSPECTION REPORT

For the Property at:
123 Main ST
FRISCO, TX 75034

Prepared for: John Doe Inspection
Date: Friday, May 1, 2020 Prepared
by: Patrick Evers

PROPERTY INSPECTION REPORT

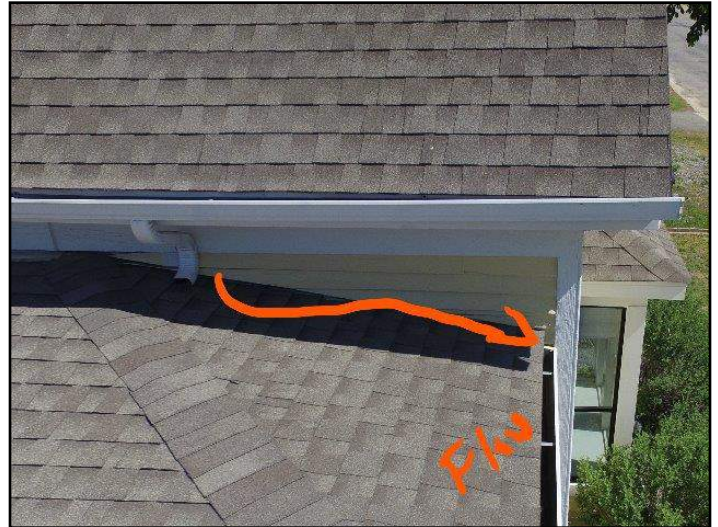
Roof/wall flashings: **Roof Siding/Trim min 1" from Shingles. This should prevent wood rot and moisture wicking into home.** Notes: **Seeing damaged corner from water wicking.**

6. Roof Siding/Trim min 1" from Shingles. This...

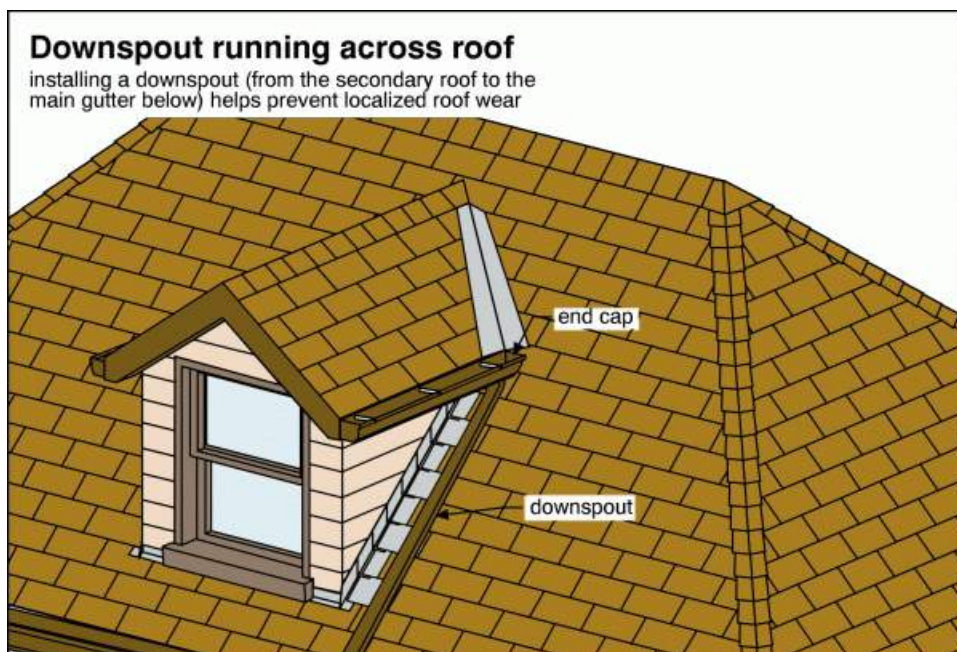
Redirect water from siding.

Implication(s): Chance of water damage to contents, finishes and/or structure

11. Discharge onto roofs

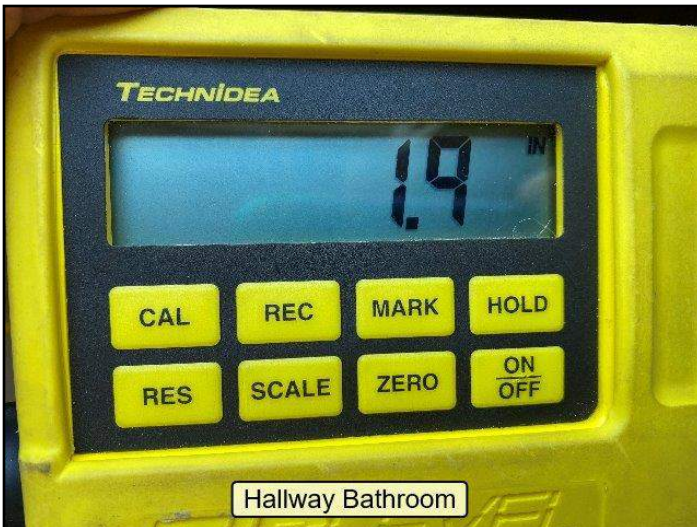
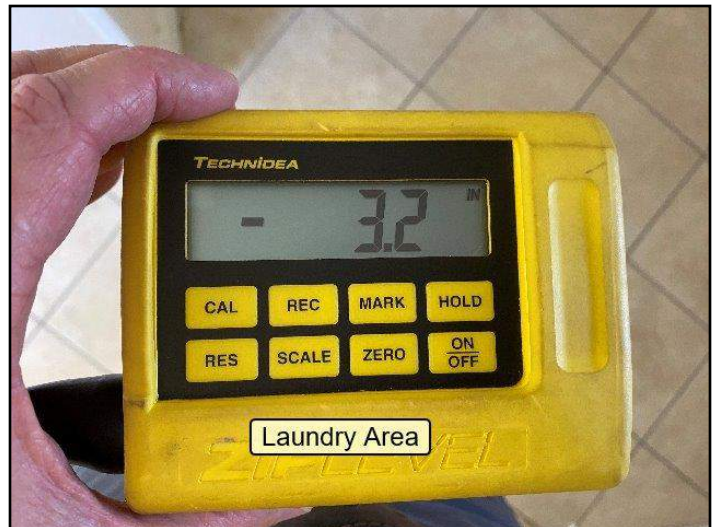
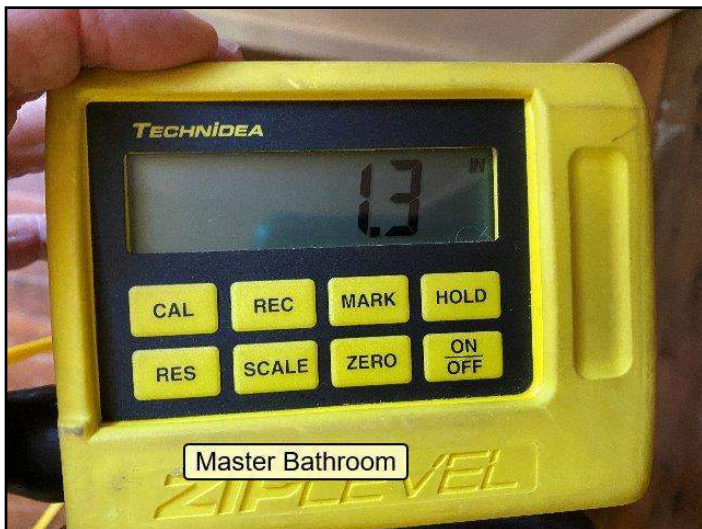
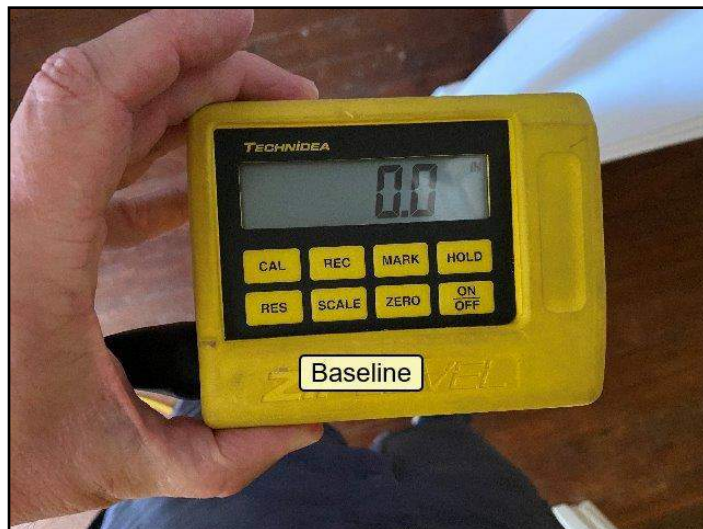
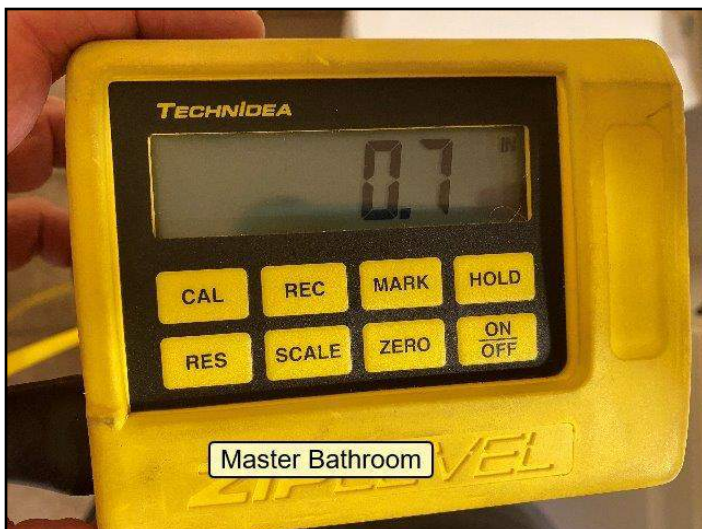
- Elevation check of home (Specification difference should be less than 2.0")

Baseline stairs 0.0", master bedroom NW corner 1.3", master bathroom 0.7", hallway bathroom 1.9", laundry area -3.2", NE bedroom NW corner -3.4", living room SE corner -1.3", Entry -0.7", kitchen -0.5",

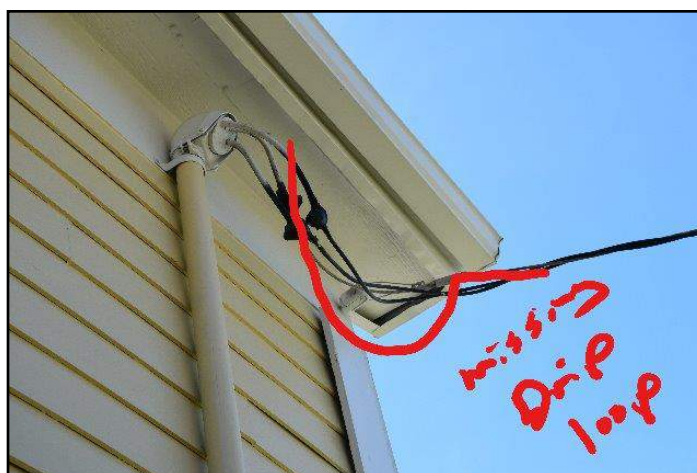
the primary purpose of the drip loop is to prevent water that runs down the service drop from getting into the service mast (and ultimately into the service panel)
the support wire for the two hot wires can also do double duty as the neutral connection for the house and is grounded back at the power pole

52. No drip loop

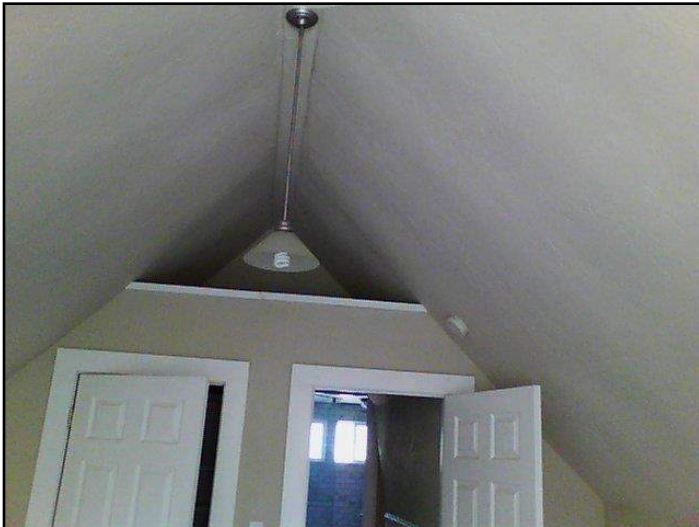
Multiply voids around the home energy loss issue. In particular the upstairs roof line.

Implication(s): Increased heating and cooling costs | Reduced comfort

59. Gaps or voids

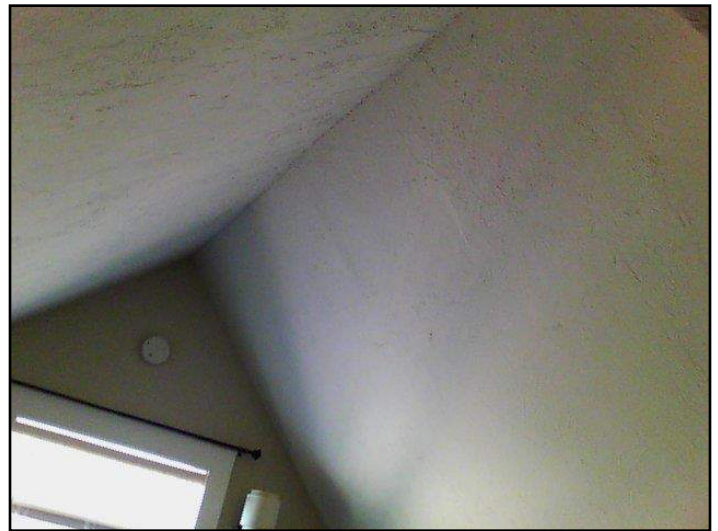
62. Gaps or voids

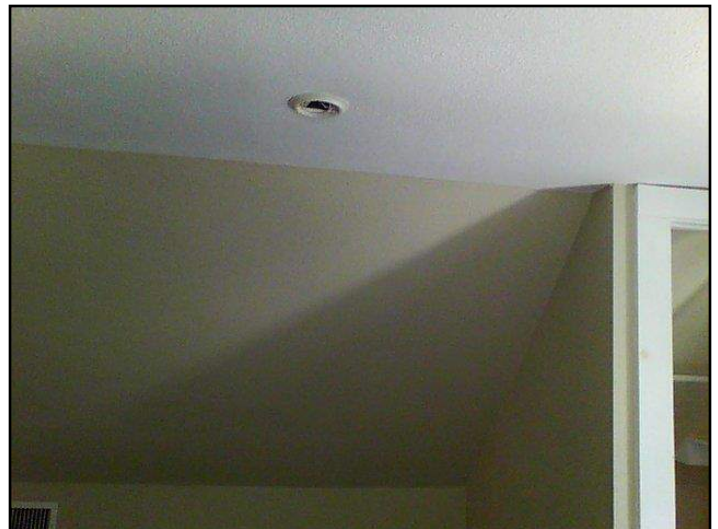
64. Gaps or voids

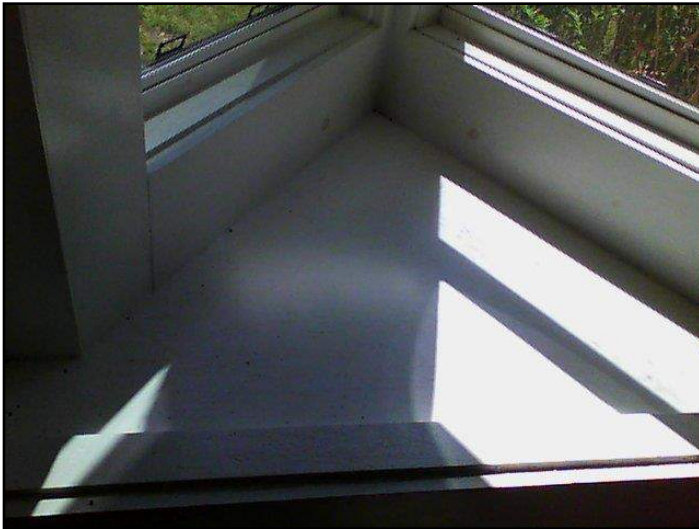
28. Condition: • Sagging or voids

67. Sagging or voids

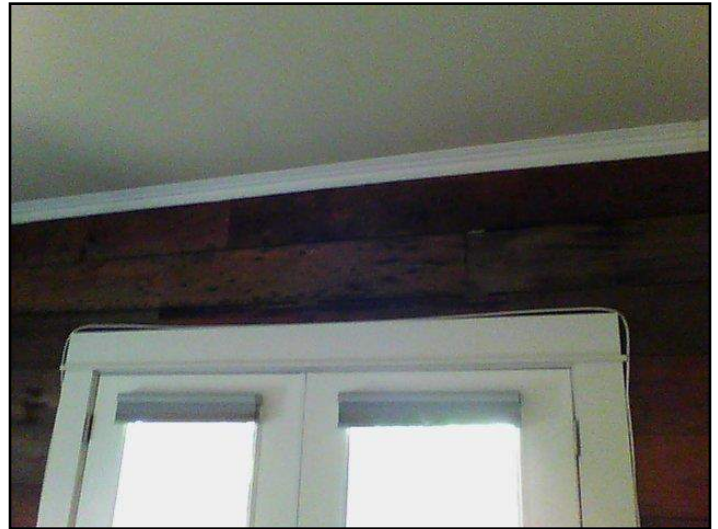
68. Sagging or voids

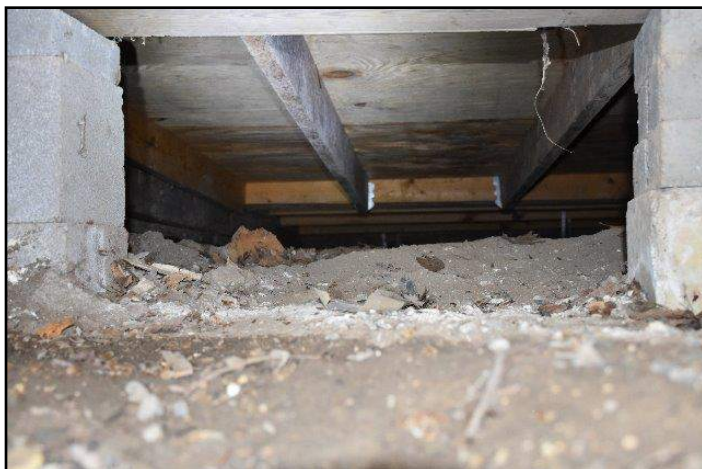
72. No vapor barrier

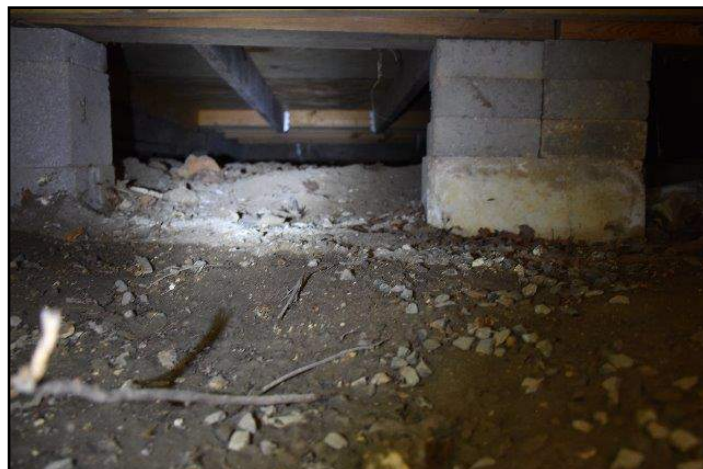
73. No vapor barrier

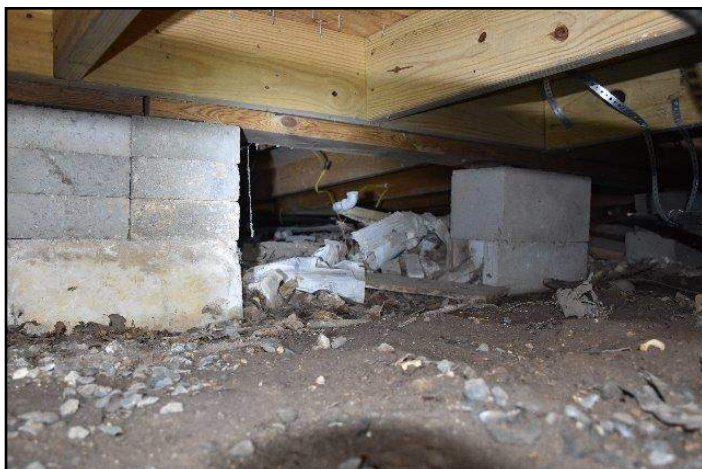
74. No vapor barrier

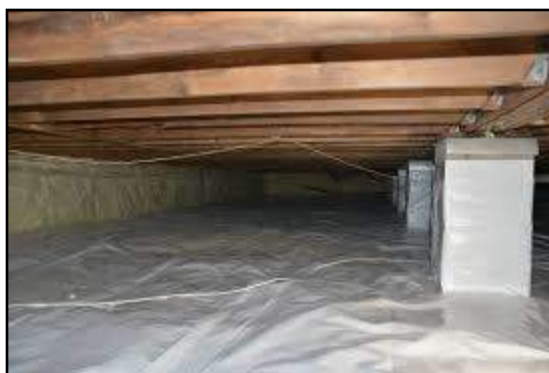
35. Condition: • To meet code requirements, the crawlspace floor should be covered with a ground cover consisting of 6-millimeter plastic that is overlapped and sealed at the edges and secured to the side walls; perimeter walls should be insulated to code-specified levels (e.g., rigid foam on the exterior or rigid fiberglass, spray foam, or rigid foam on the interior); and perimeter drainage should be provided just like a basement when the crawlspace ground level is below the ground level of the surrounding grade.

77. To meet code requirements, the crawlspace...

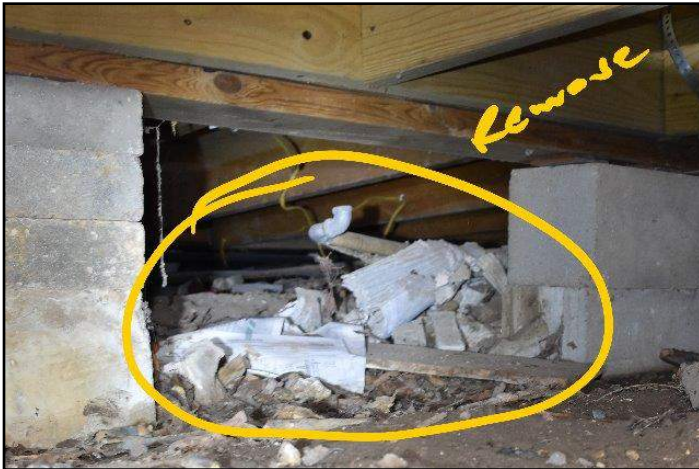
37. Condition: • Wood and debris on flooring this could attract termite and insects. Remove all wood from flooring.

78. Wood and debris on flooring this could...

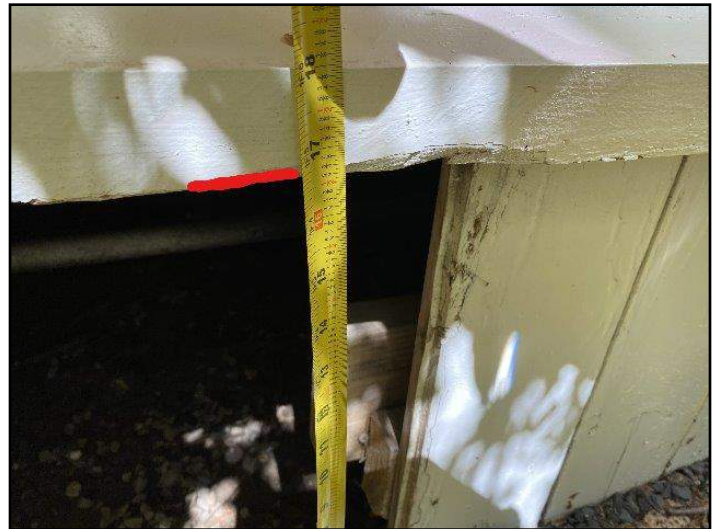
39. **Condition:** • Too small

81. Too small

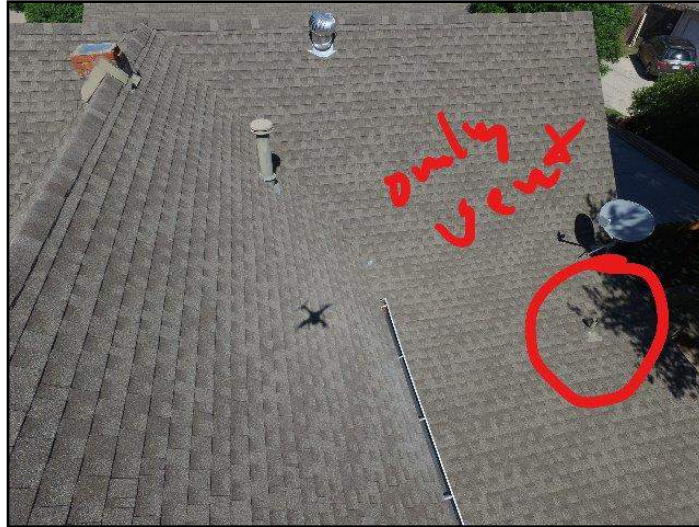
44. Condition: • Ineffective

Only one exterior vent may cause drainage issue. Code only requires one vent system serving each building drain shall have not less than one vent pipe that extends to the outdoors. Recommend add additional vent lines or using air admittance valves.

Implication(s): Sewer gases entering the building

89. Ineffective

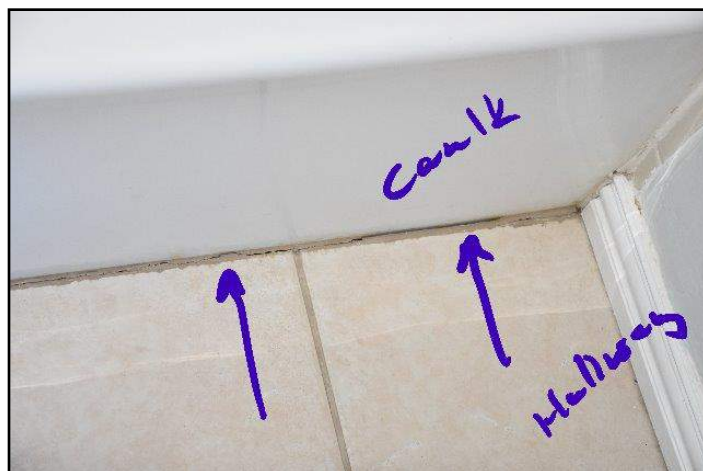
51. Condition: • Caulk Tub and Tile interface water entry point can loosen tiles.

97. Caulk Tub and Tile interface water entry...

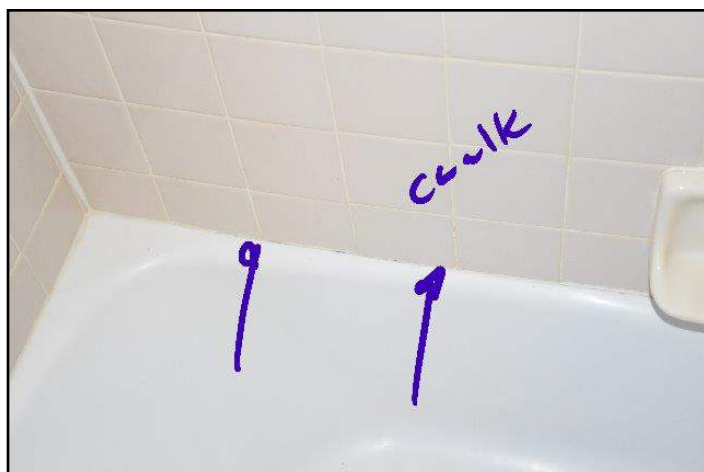
98. Caulk Tub and Tile interface water entry...

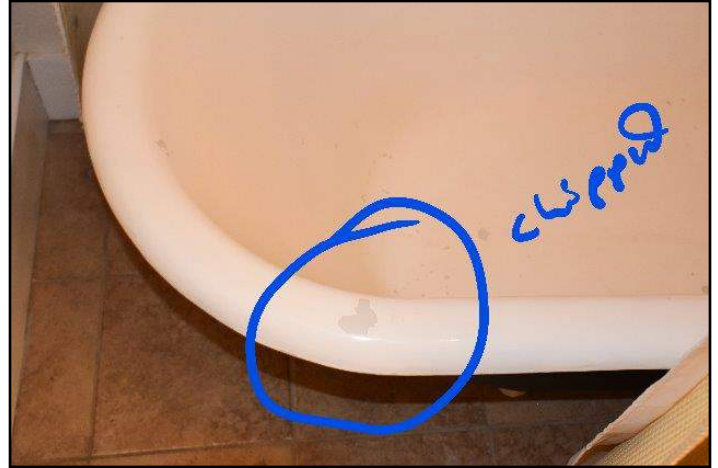
101.

52. Condition: • Tub resurfacing/paint chipping needs to be repaired.

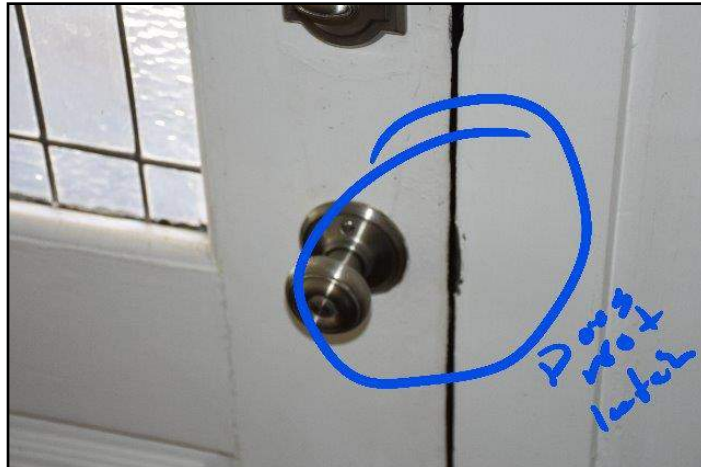
61. Condition: • Latch not effective on exterior door

Entry door does not latch

Implication(s): Poor security

117. Latch not effective on exterior door

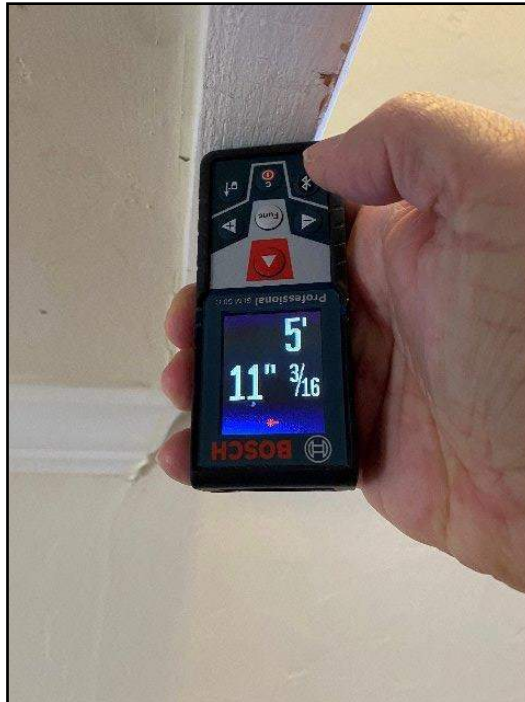
63. Condition: • Headroom less than ideal

Vertical clearance above any stair tread to any overhead obstruction is at least 6 feet, 8 inches (203 cm), as measured from the leading edge of the tread.

Implication(s): Physical injury

119. Headroom less than ideal
